Optimization of Constellation Energy's SNCR System at Crane Units 1 and 2 Using Continuous Ammonia Measurement

**Presented at the AWMA, EPA, EPRI, DOE Combined Power Plant Air Pollution Control
"Mega" Symposium, August 30-September 2, 2010, Baltimore, MD**

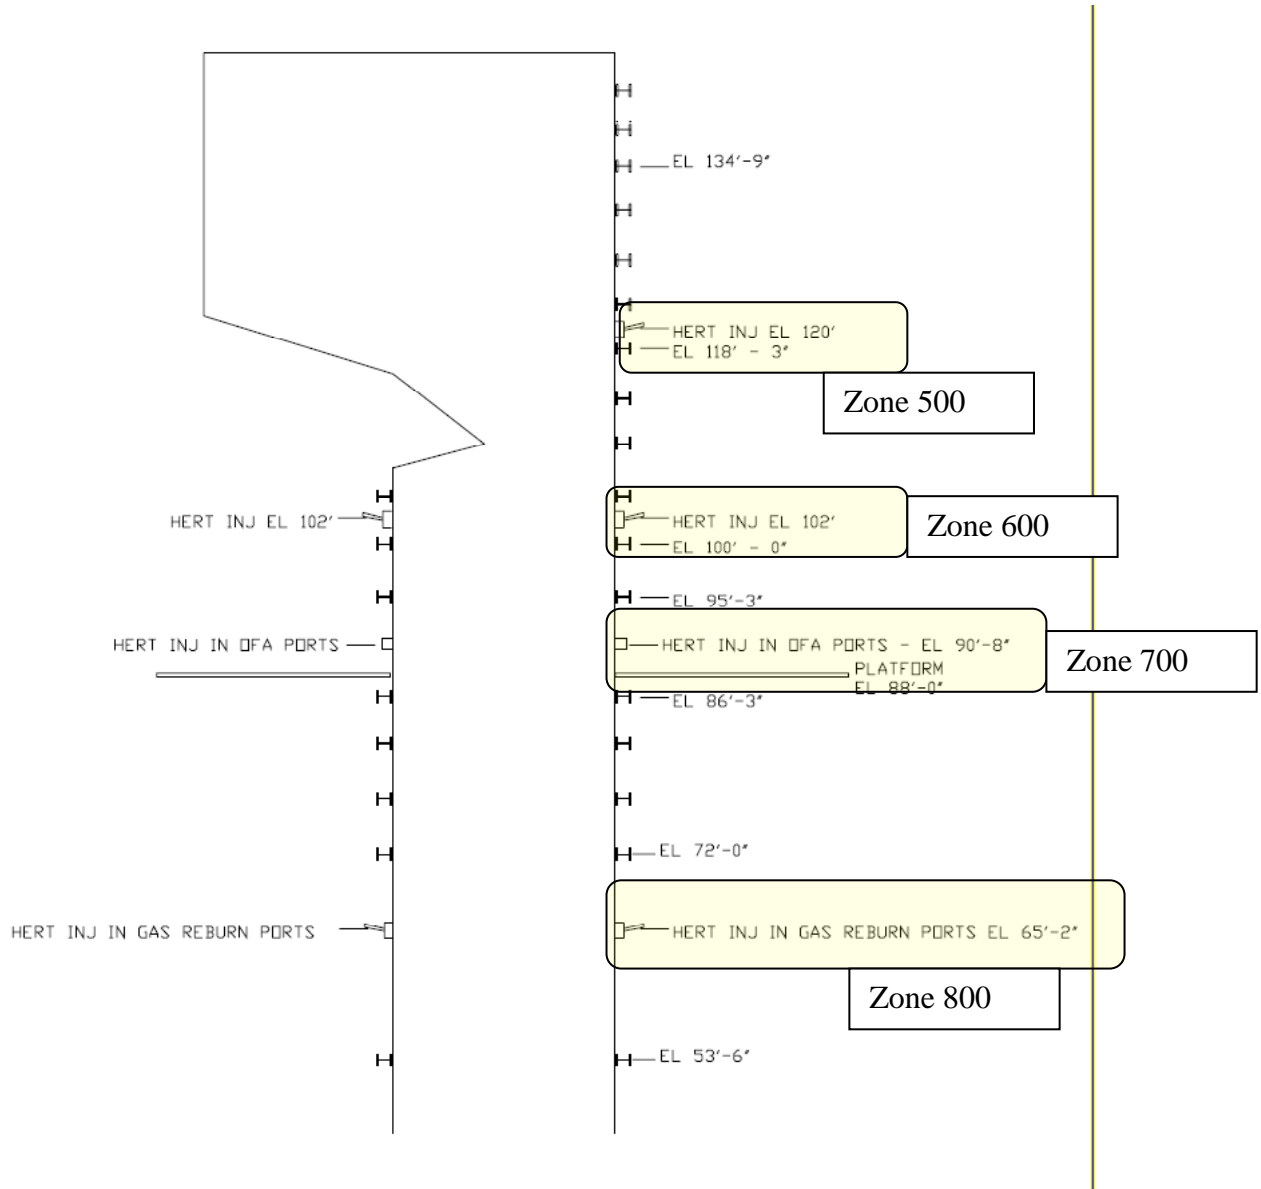
The HERT systems are similar for both units, and include four zones of injection, numbered 500, 600, 700, and 800 - from uppermost to lowermost injection zones, as shown in Figure 1.

- The lowermost injectors (zone 800) inject urea into the boiler at the 65 foot elevation above the cyclones but below the OFA for Rich Reagent Injection. These ports were formerly used for gas injection when gas reburn was employed.
- The next zone (700) injects urea through the OFA ports at the 91 foot elevation.
- The 600 zone injects reagent into the upper furnace at the 102 foot elevation,
- And the 500 zone injects reagent slightly above the nose arch at the 120 foot elevation.

Figure 1. Crane 1 and 2 HERT SNCR Injector Locations

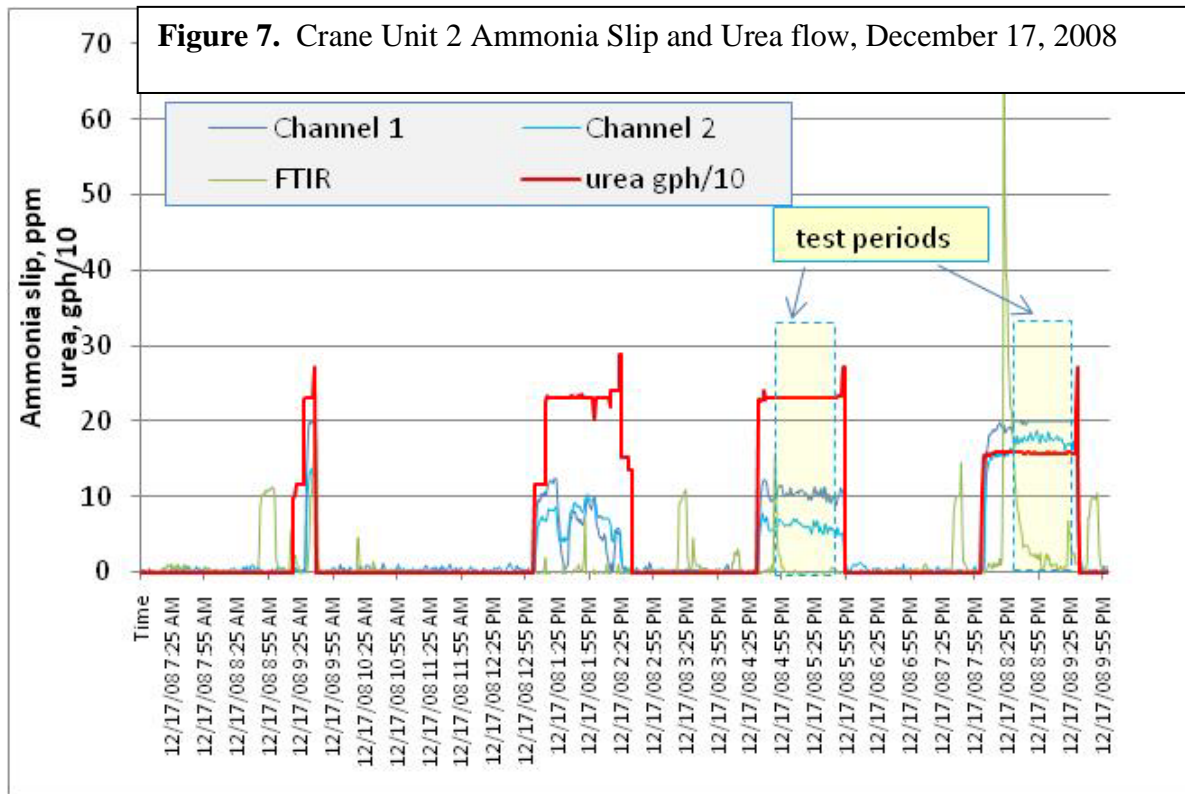
Because of the differences in measurement method and somewhat different locations, the same results should not be expected from both methods. However, ideally there would have been better correspondence between the results of the two methods. Figures 6 and 7 show ammonia slip from the TDLAS instruments (taken from the plant PI system), from FTIR raw data for ammonia slip (provided by the testing company) and urea injection rate (in gph/10) for December 16 for Unit 1 and December 17 for Unit 2 plotted versus time. The two acceptance test periods are highlighted in yellow. It is uncertain how well synchronized the time of the test company raw data is with the reported time in the PI data. But, it is reasonable to expect that there should not be more than a few minutes difference. The actual reported FTIR values for the purpose of the acceptance test are discrete points that fall along the FTIR line 5 minutes after the probe is moved to the sample point (it is not possible to tell from this data when the probe is moved, except possibly each “jump” is a different point). The most remarkable characteristics of these plots are:

- The FTIR shows spikes above 10 ppm and even up to 60 ppm although all of the reported results were well below those values.

- There are occasional times when slip is high by both methods even when no urea is being injected.
- In most situations, the TDLAS instruments seem to respond to urea injection more consistently (this might be due to the fact that every 10 minutes or so the FTIR probe is moved to a different location)

Figure 5. Comparison of TDL versus Extractive FTIR

Most concerning is the first bullet point – particularly the very high spikes to 60 ppm. It does not seem likely that ammonia slip in the duct is peaking quickly to values like 60 ppm and then dissipating since it would likely be picked up on the TDLAS instruments. Another explanation is that perhaps ammonia may be collecting in the FTIR probe or sample line only to be released suddenly, perhaps when the probe is moved or after enough ammonia has built up. When the test company was asked about this while on site, they did not have an explanation except that when the FTIR does see the ammonia spikes, there is definitely ammonia present.

The second bullet point suggests that perhaps during SNCR purge cycles or other conditions, urea was being admitted to the furnace although the urea pumps were not running. And, the third bullet indicates that the TDLAS instruments are responding to ammonia as expected.

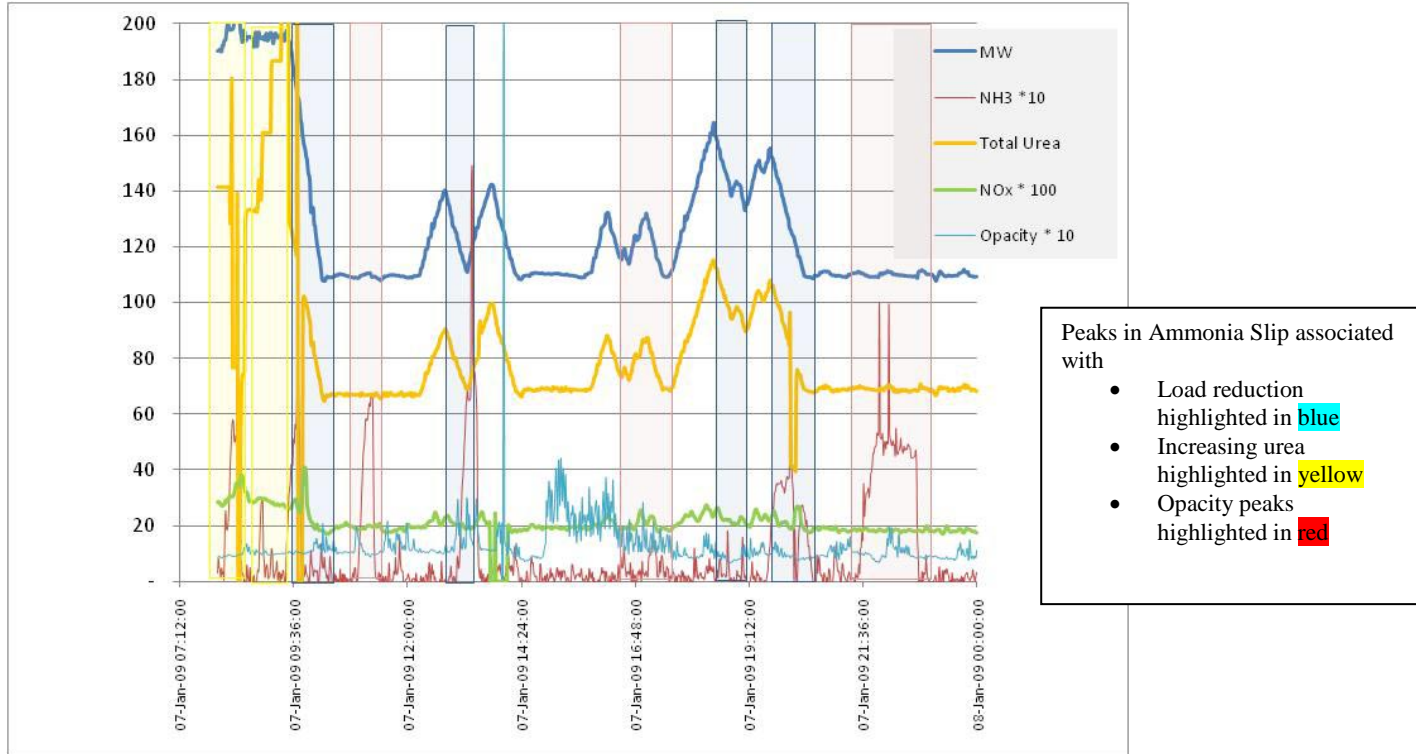
Figures 8 and 9 are plots of MWg, NO_x, total urea flow, ammonia slip and opacity for Unit 1 and Unit 2, respectively on January 7, at a very early period in the optimization program. Peaks in slip associated with load reductions highlighted in blue, peaks that occur with increases in opacity highlighted in pink and increases in slip that occur with increases in urea injection are highlighted in yellow. There are large increases in opacity that do not correspond to increases in

Figure 8. Unit 1 SNCR Operation 7 January, 2009

The periods shown in Figures 7 and 8 when NO_x equals zero are when the NO_x analyzer is in calibration and the data was removed from the analysis, and the spikes in NO_x that appear when urea is being injected are during brief jumps in oxygen or an imbalance in main air pressure.

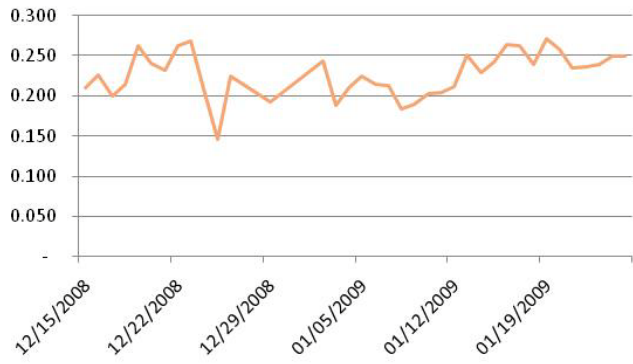
Daily averages over these two periods were evaluated for trends. As shown in Figures 12 a, and b, daily averages of NO_x on Unit 1 remained roughly the same while ammonia slip trended downward over the period. Average daily load (MWg) and urea consumption (in gallons/MWh) for unit 1 are shown in Figure 12c. Urea consumption in gal/MWhr clearly is related to load. Figures 13 a, b, and c show similar results for unit 2 over the same period. Unit 2 was shut down for a large part of January 24th and 25th, which affects the NO_x level because the SNCR system is shut down when the unit is in the process of being shut down or started up, and over these days the unit spent several hours below 100 MWg with the SNCR system turned off.

Figure 12a. Unit 1 average daily NOx.

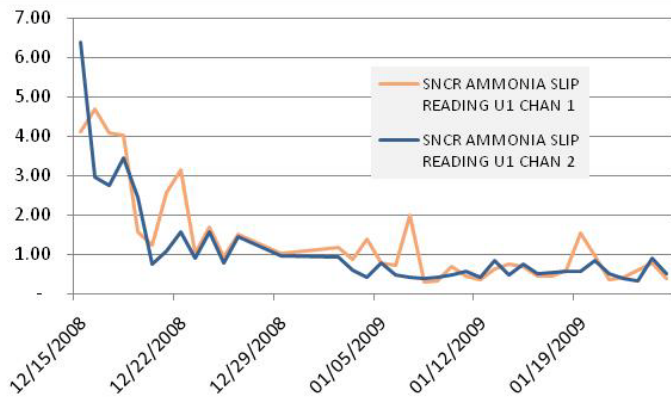
Figure 12b. Unit 1 average daily ammonia slip

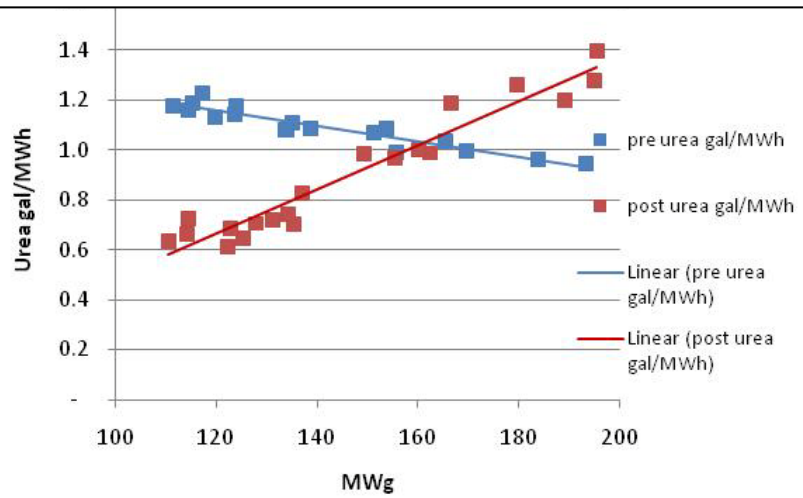
Figures 14 a and b show average urea consumption in gallons/MWghr and average ammonia slip in ppm for unit 1 versus MWg. As shown, there is a clear relationship. Urea consumption was reduced sharply (by about 50%) at low load conditions through optimization but increased somewhat (about 20%) at high load conditions through optimization. However, across the load range ammonia slip was reduced significantly. So, the slight increase in urea consumption at high loads on unit 1 was the price for reducing ammonia slip. As shown on Figures 15 a and b, on unit 2, urea consumption was reduced at all loads except full load; however, ammonia slip was reduced across all loads, and particularly at full load.

Figure 14a. Unit 1 daily avg urea consumption in gal/MWhr versus avg load in MWg

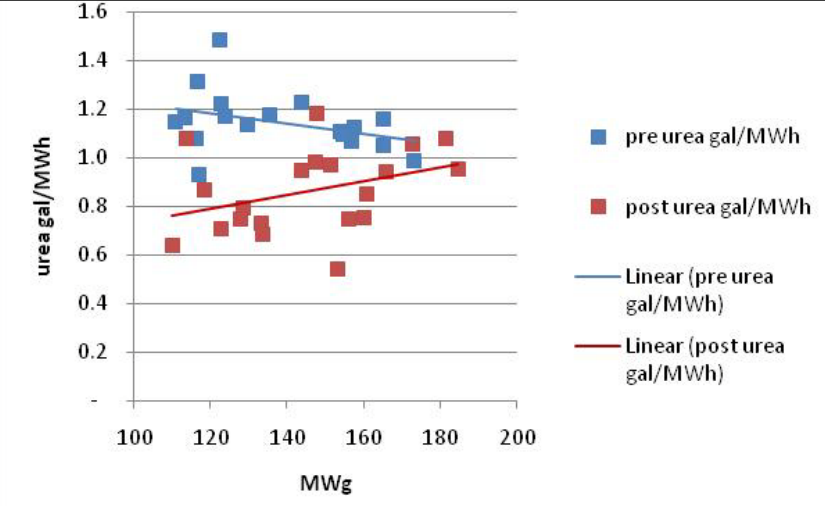
Figure 15a. Unit 2 daily avg urea consumption in gal/MWhr versus avg. load in MWg

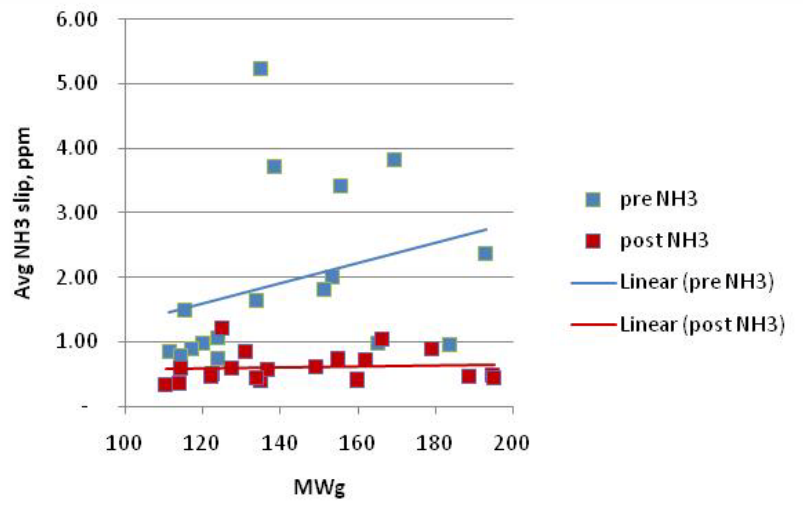
Figure 14b. Unit 1 average daily ammonia slip v avg load in MWg

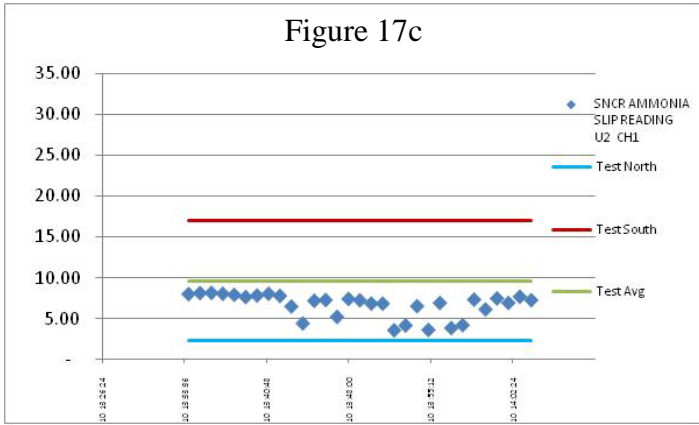
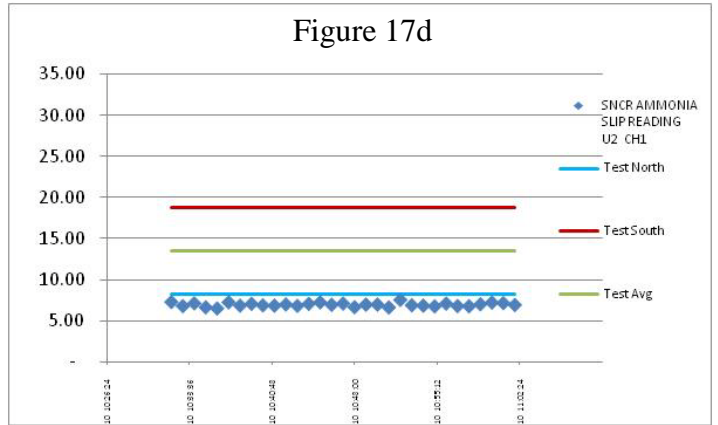
Figures 17a through 17f represent the results of the six different tests. These figures plot the minute by minute PI data for ammonia slip from channel one of the Unit 2 instrument over time, the north (blue) and south (red) side of the duct average readings as well as the average of the two. Since the test values are samples taken over a period of time, they cannot capture changes during that time, but represent the average for the sample over that time. A vertical scale of 0 to 35 ppm is used for all figures so that the figures are comparable to one another and the differences in ammonia slip levels from one test to another can readily be compared. These are arranged from lowest ammonia reading (a) to highest ammonia reading (f) rather than in the time order that the test was conducted. In Figure 17b the instrument reading falls off to zero. This is because the urea pumps tripped off during this test. What is apparent in Figures 17a through 17f are:

- There is significant stratification of ammonia in the duct, with much higher concentrations on the south side than the north side, particularly at higher concentration.
- The ammonia instrument generally tracks between the north and south side concentrations, except at higher concentrations where the instrument tends to indicate closer to the lower concentrations on the north side.
- When urea tripped off the instrument clearly responded as expected.
- At lower slip levels, the instrument seems to have a good correspondence with measured test values

Because of the high stratification of ammonia slip when there are higher slips, it is difficult to make direct comparisons for the purpose of gauging accuracy, but clearly the instrument is responding with higher slips that are generally within the range of the test measurements. Whether or not there is an inherent bias in the method to lower numbers in situations such as this one is unclear.

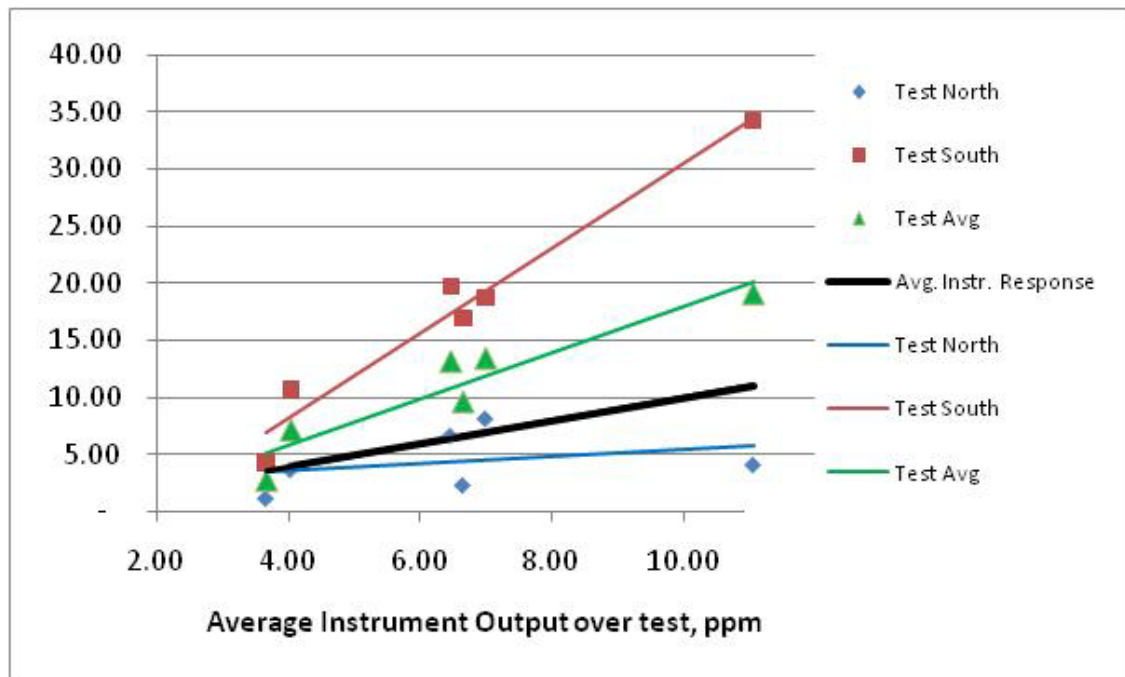
Figure 18a shows the same data in a different way - the north and south wet chemistry test results plotted against the average of the instrument indication over the test period. This figure shows that, while the instrument does not precisely agree in magnitude with the wet chemistry measurements – especially at high loads – it does respond to changes in ammonia levels. At low ammonia slip levels, the correspondence with wet chemistry results is much better than at high load.

Figure 18 Comparison of wet chemistry test results to average instrument indication over the test period
